The 2006 NOAA-14 Tumble Anomaly

This paper describes a NOAA-14 spacecraft loss of control event and the lessons learned from it. The lessons learned are in two categories; Contingency recovery operations and on-orbit propulsion system isolation methods. The work is motivated in recognition of the effort of the NOAA off-line engineering support team and their NOAA civil servant mission leads and operations support staff

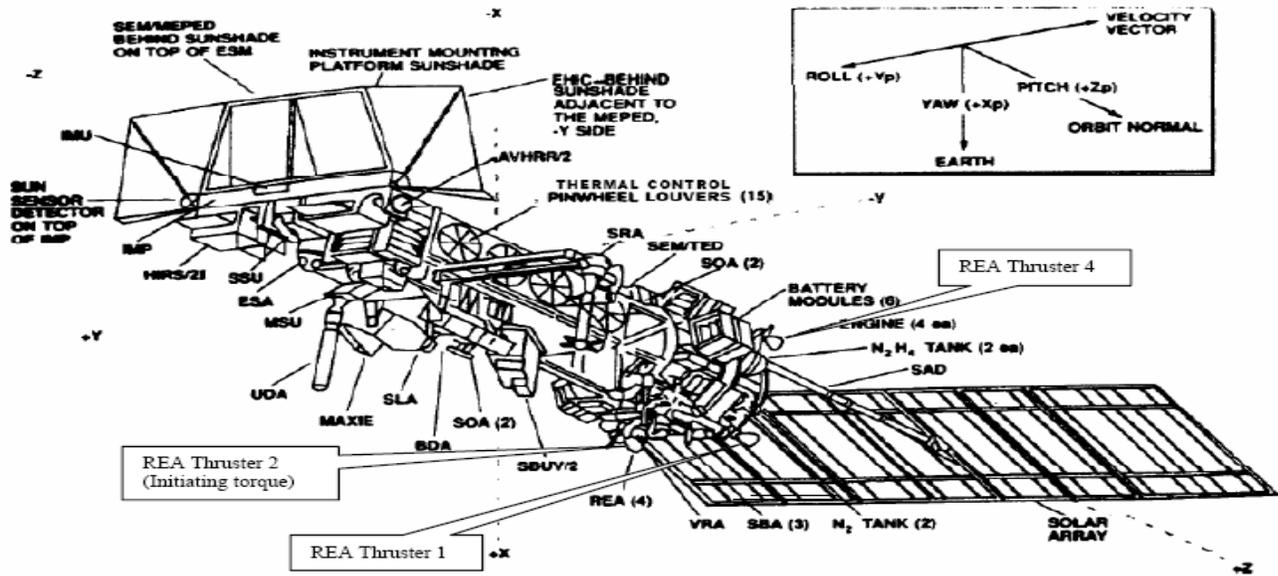
Figure 1. NOAA-14 REA Thruster Configuration and Plume Exhaust Direction

A representation of the NOAA-14 spacecraft is presented in Figure 1 annotated to show the REA thruster locations and to reveal their plume directions relative to the solar array.

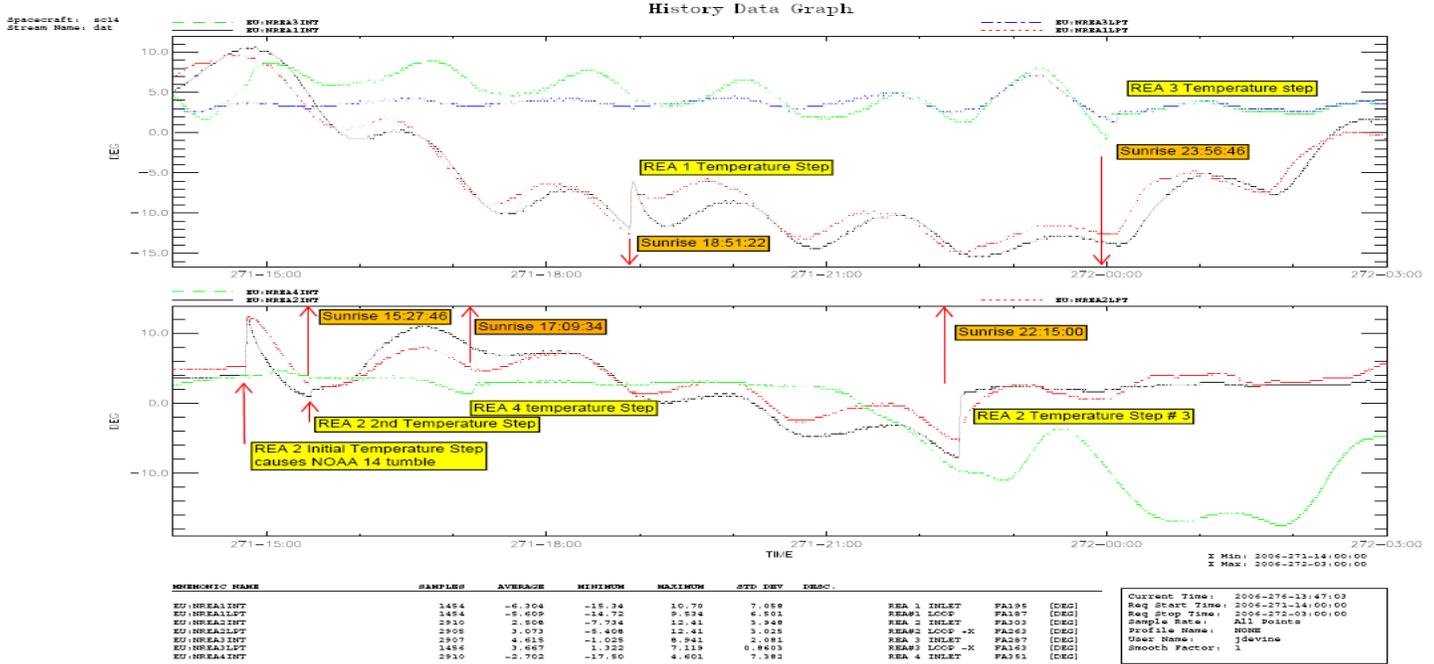
Figure 4. REA Thruster Temperatures For 13 Hours During the Event

The cause of the tumble was not immediately understood from the indicators available in real time telemetry and event logs. However, by the following Monday (DOY 275), with the advantage of playback telemetry and experience with a similar type of event on NOAA-17 (Ref. 1), it was determined to be a sudden release of propellant through the 100 lbf hydrazine Rocket Engine Assembly (REA) #2. The evidence for this conclusion was a simultaneous step increase of $\sim 7^\circ$ C in the propellant line inlet and loop temperatures for thruster 2, coupled with the rapid, 140-degree reverse motion of the solar array. The prop line and loop temperature sensors are located at the entrance to the thruster valve and ~ 7 inches upstream respectively on the $\sim 3/8''$.O.D., 0.028'' wall tubing (Ref. 2). The data also indicate a hydrazine leak, which lasted ~ 45 seconds and affected the whole REA propellant manifold. This fact is substantiated by thermistor data indicating similar leak thrusts occurred at all 4 REA thrusters over the next 10 hours. Specifically, there were positive steps in the inlet and loop thermistor temperatures at the times of Sunrise between 14:47 UTC and at the last step increase in the REA 3 thermistors at 23:56 UTC.

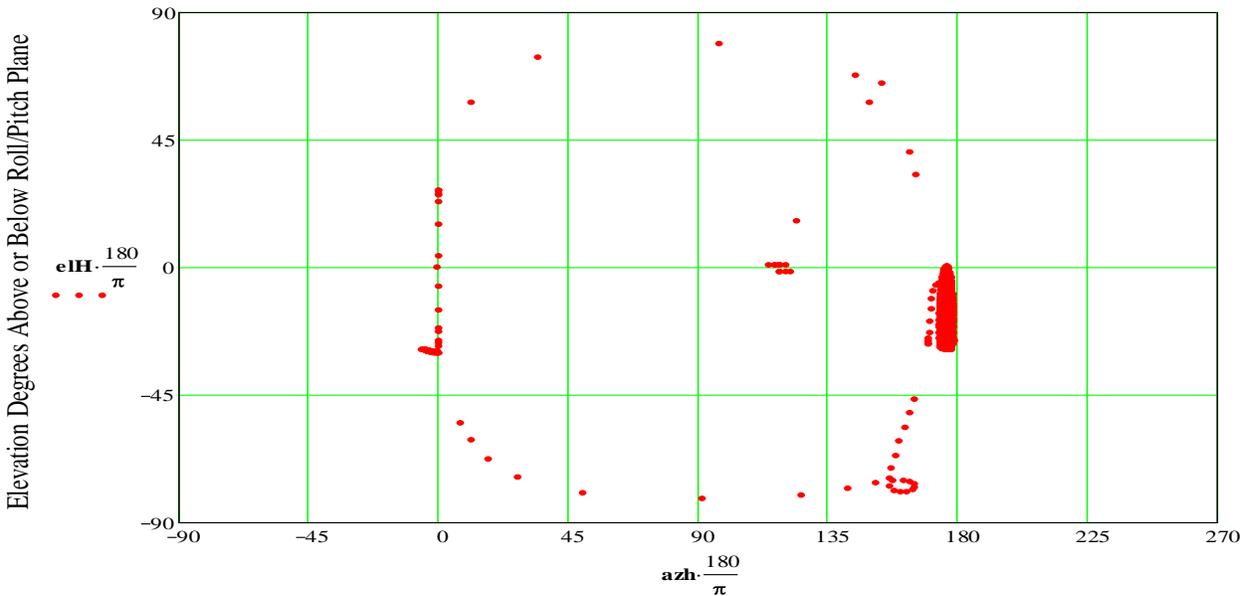
Figure 5. Total Spacecraft Angular Momentum in the Body Frame From 14:47 to 22:30 UTC

Figure 5 shows the evolution of the angular momentum vector in the body frame. More accurately, assuming that the torque free motion occurs within 5 minutes of the initial impulse, Figure 5 illustrates the motion of the body frame around angular momentum vector which is inertially fixed in a direction close to the orbit plane and the Earth north pole. This data is derived in three steps; 1) A recovery of saturated roll rates using solar array current to determine total spin rate 2) Multiplication of this reconstructed body rate vector by the deployed MOI, from (Ref. 2 and 3) Unitization of the unit angular momentum vector and translation into body frame azimuth and elevation.

This rough attitude vector is from analysis, not documented here, which used an approximate model of Earth Sensor Assembly (ESA) quadrant cuts based upon spin rates determined from the solar array current periodicity. Here each row of data starting at the lower left of the graph is precisely one orbit, offset on the y-axis to illustrate the similarity of each orbit and repetitive nature of the spin phase. Figure 6 shows that the history of the Advanced Very High Resolution Radiometer (AVHRR) radiator temperature throughout the event. In the figure, the long period rise and fall are correlated with spacecraft day and night, and the short noise-like saw tooth oscillations are due to the

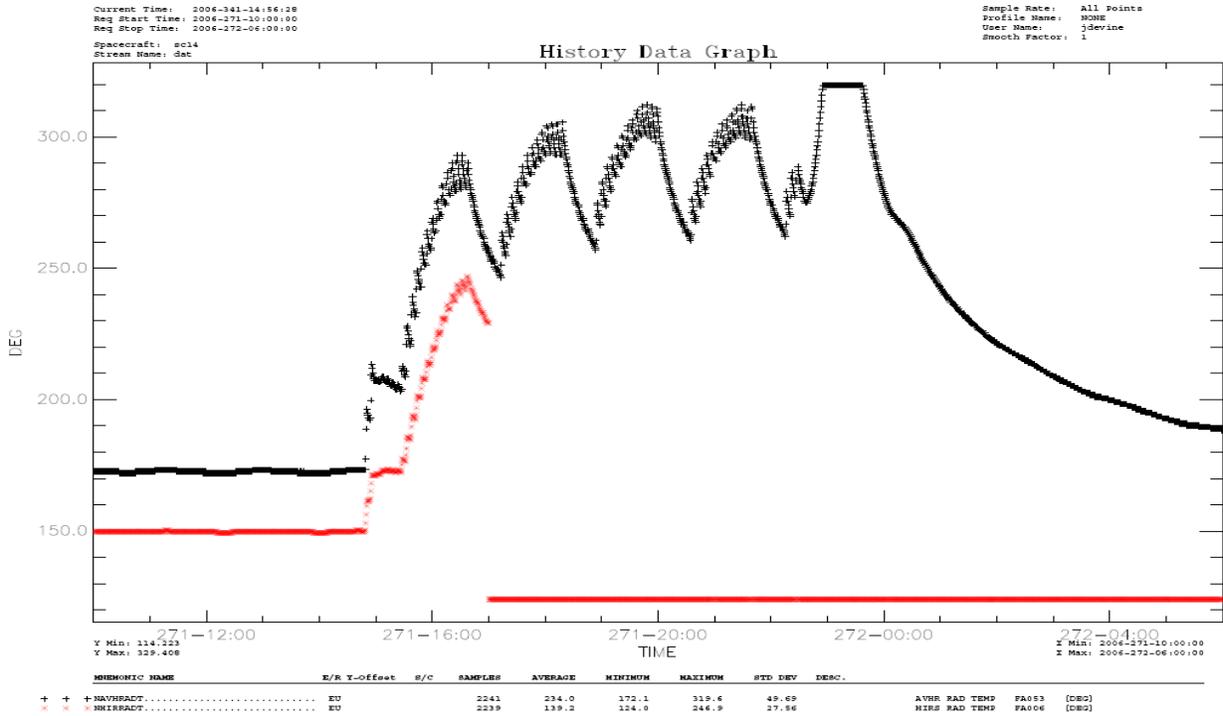
Figure 6. AVHRR Radiator Temperatures for 20 Hours Spanning the Event

spacecraft spin as the radiator passes the Earth and/or Sun during day or night. Finally, after the de-spin at 22:30 UTC the ending geometry has the radiator aperture illuminated by direct sunlight for approximately 40 minutes.

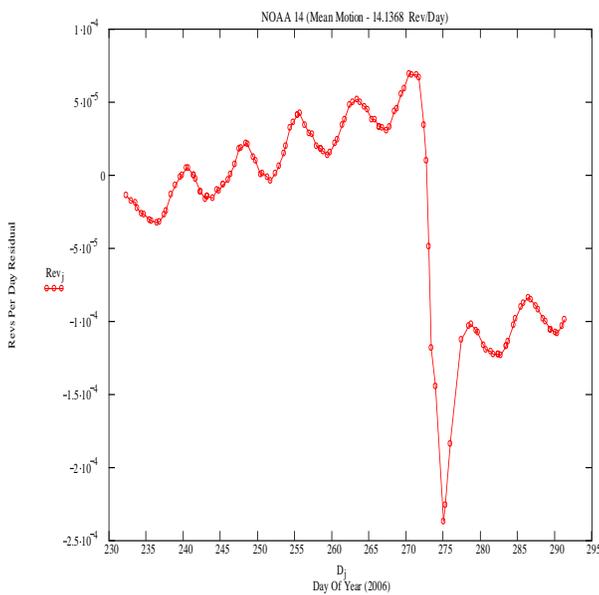
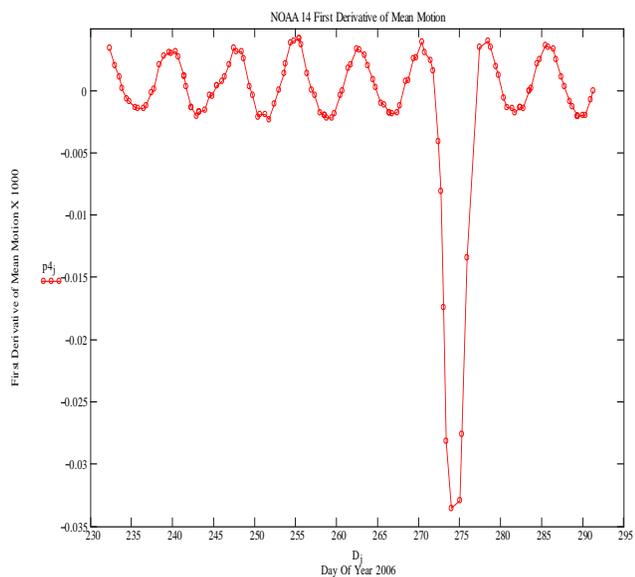
The NORAD Two Line Elements for 60 days including the event were analyzed to investigate the effects on the orbit. Figures 7 and 8 show a discontinuity in the mean motion parameter and the corresponding impulse in the first derivative of the mean motion. From these data it was determined that the along-track delta-V was +0.026 meters per second, corresponding to a 0.65-Newton force applied for 45 seconds.
